Reserve Study Update.com, LLC

Chelan at Cascade Summit
Chelan Drive & Chaparrel Loop
West Linn, Oregon 97068
Account 928 - Version L

Fiscal Year: October 1, 2017 to September 30, 2018

RESERVE STUDY & MAINTENANCE PLAN

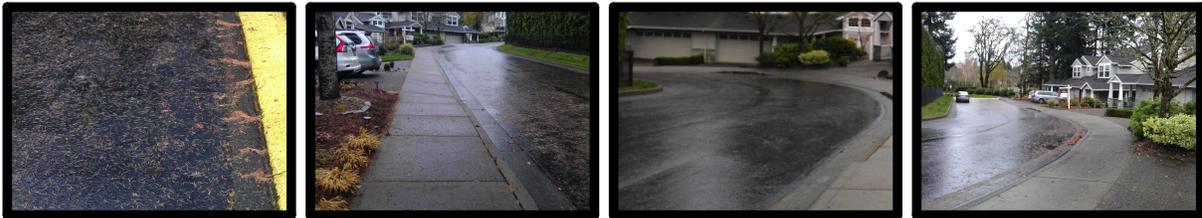
This line item is for the 1.5 inch to 2 inch overlay surface including re-setting of the manhole/valve covers and allowance for the butt-joints and grinding of edges. Re-sealing of the asphalt surface every 3 to 5 years will prolong the asphalt surface. Asphalt observed appeared to be in good overall condition with minor cracks in some very limited areas.

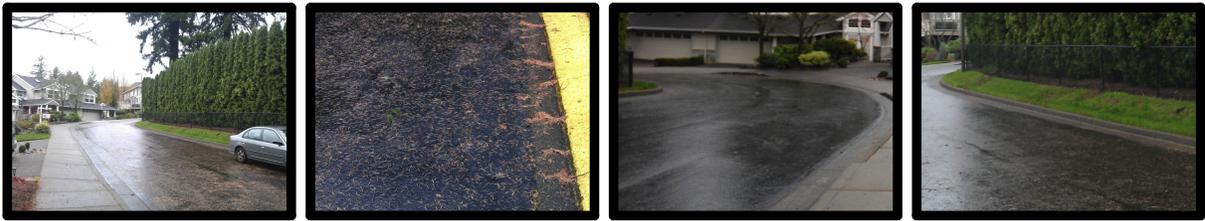
This line item is for the seal coat for the asphalt surface every 5 years. Application of seal coat every 3 to 5 years will maximize the life expectancy of the asphalt overlay. Cost does not include re-striping, curb painting, and ADA stencils with DOT paint as needed. This line item should coincide with "Asphalt Repair" cycle.

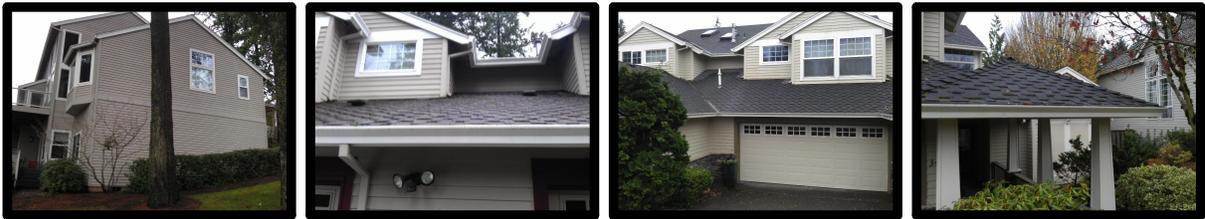
This line item is for the roof maintenance of all roofs located in the community which is above and beyond the bi-annual cleaning. The roof is an asphalt composition. ReserveStudyUpdate.com, LLC recommends roof maintenance every 5-6 years as this measure will likely extend the life of the roof up to 20% or more; depending on the frequency and level of care. Roof maintenance includes but it not limited to moss removal and algae treatment and detecting and addressing dry-rot repair as needed.

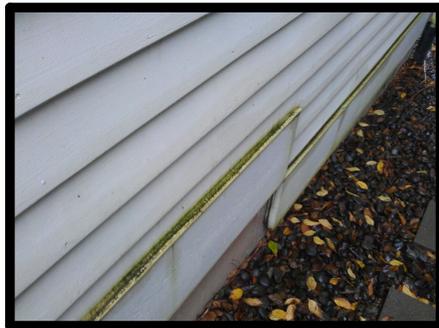
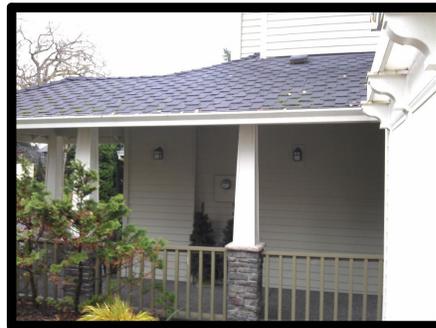
This line item is for the painting of the exterior on building unit #1. Cost and timing by the Board. Paint presently appears to be in fair condition. Photos presented above represents photographs from all units, not profiling one specific unit or design.

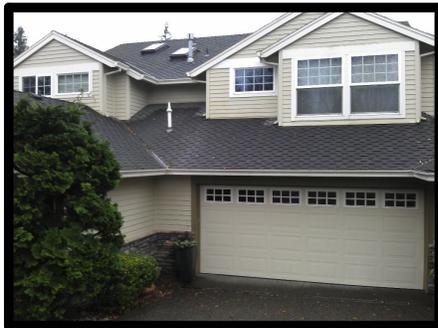
This line item is for the painting of the exterior on building unit #2. Cost and timing by the Board. Paint presently appears to be in fair condition. Photos presented above represents photographs from all units, not profiling one specific unit or design.

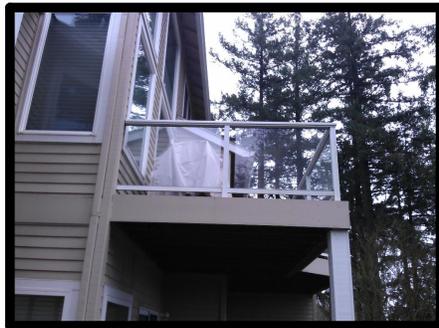
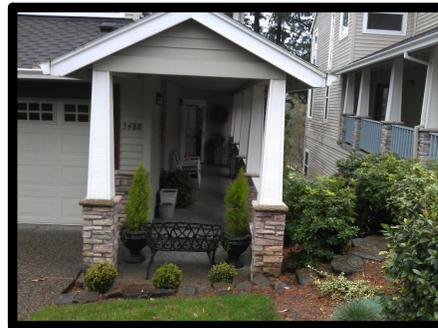
This line item is for the painting of the exterior on building unit #3. Cost and timing by the Board. Paint presently is in fair condition. Photos presented above represents photographs from all units, not profiling one specific unit or design.

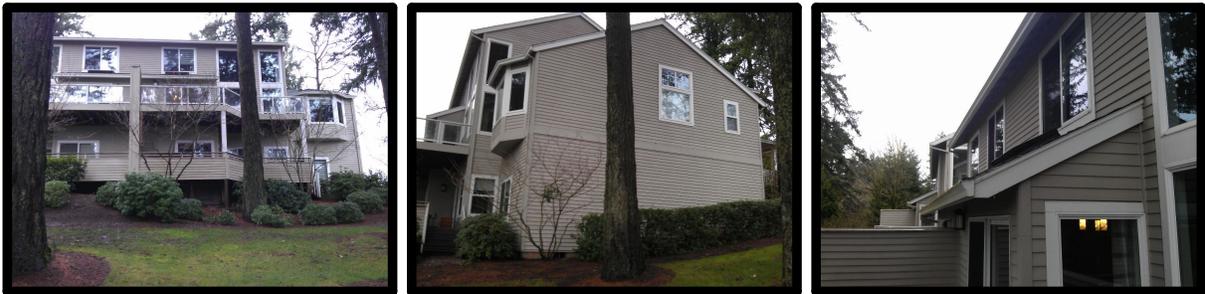
This line item is for the painting of the exterior on building unit #4. Cost and timing by the Board. Paint presently is in fair condition. Photos presented above represents photographs from all units, not profiling one specific unit or design.

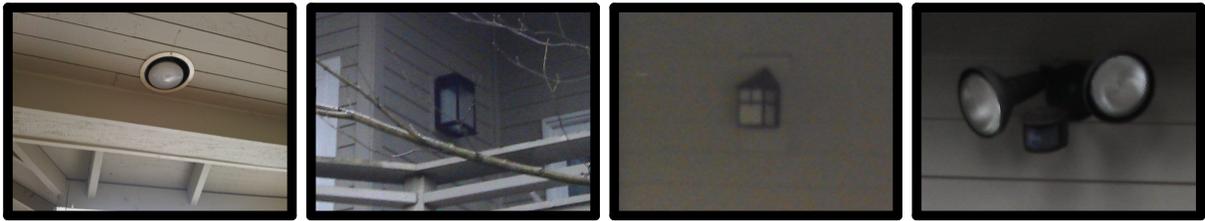
This line item is a provision for the replacement of the various exterior light fixtures every 30 years. The analyst estimates that the total value of the existing fixtures is \$1500.

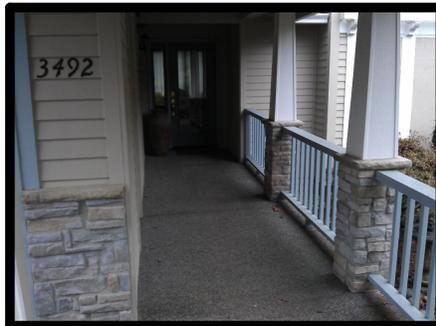
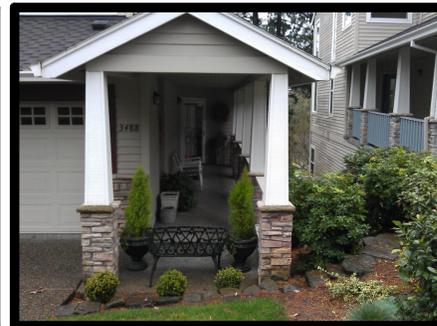
This line item is for any rebuild needed for the wood columns on the porches on an 10-year cycle. Assets should be evaluated by a licensed professional and addressed every 10 years, or during the building envelope inspection, whichever is sooner. These components should ideally be addressed within the scope of the paint cycle in order to properly match color and avoid overlap in mobilization charges.

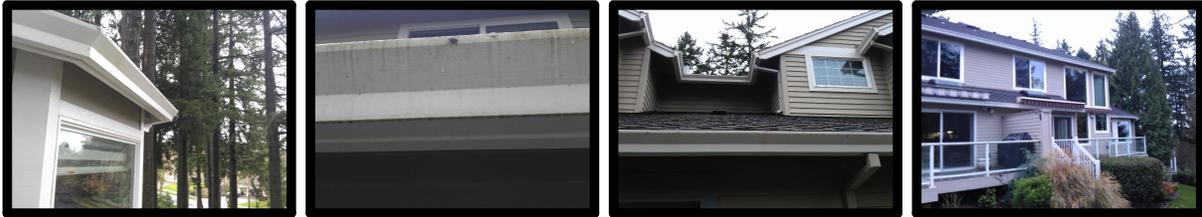
This line item replaces approximately 10% of the gutters on the 40th anniversary of the initial installation with an additional 10% of the gutters being replaced every ten years thereafter for the 30-year horizon of the reserve study from a 2017 vantage point. This activity is in conjunction with a 40% line item which addresses the gutters on the 30th anniversary of the installation. This will be reevaluated each year and the future reserve studies will be adjusted in order to compensate. The reserve study report is a constantly moving target and the report will be updated as the facts about the condition are better known.

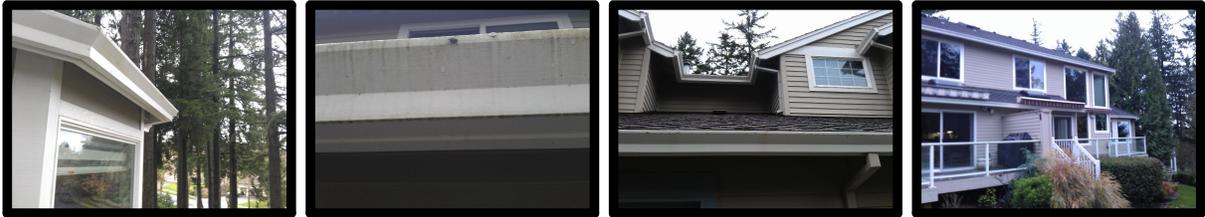
This line item replaces approximately 40% of the gutters on the 30th anniversary of the initial installation with an additional 10% of the gutters being replaced every ten years thereafter. This will be reevaluated each year and the future reserve studies will be adjusted in order to compensate. The reserve study report is a constantly moving target and the report will be updated as the facts about the condition are better known.

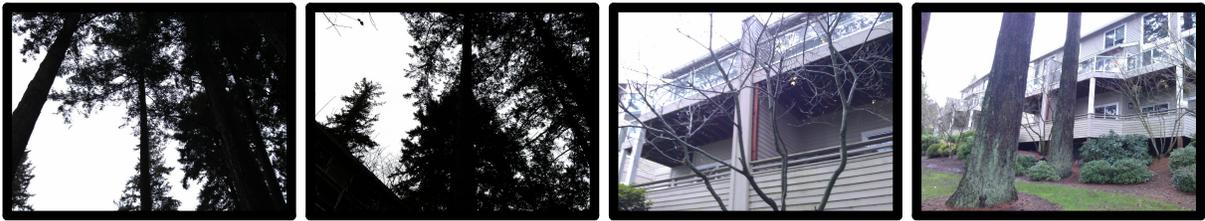
This line item is for the possible costs associated with the removal and replacement of diseased and/or falling trees which may require the services of a certified arborist and necessary permits & approval by the City of West Linn. There is a handful of trees which surround the property which the association is responsible to maintain which is outside the scope of the routine landscaping contract. This should not be confused with the trees which the master association is responsible to maintain which have not been budgeted for in this reserve study..

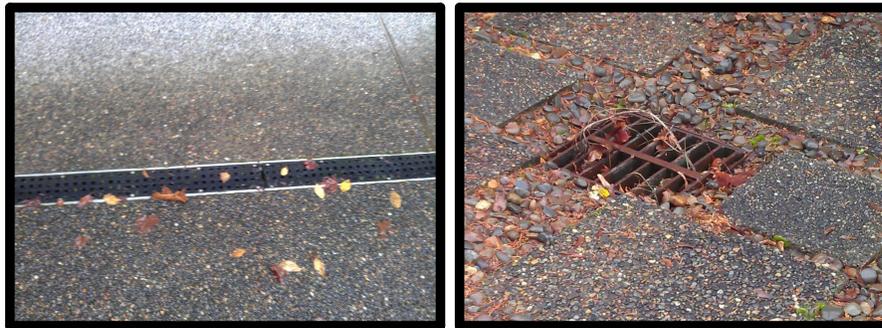
This line item is for any necessary underground utility work needed for any utilities not maintained by the utility company. Also included is a provision for any major storm drain work beyond routine cleaning. A condition assessment is not possible as the underground components fail sporadically and are not visible without specialized equipment.

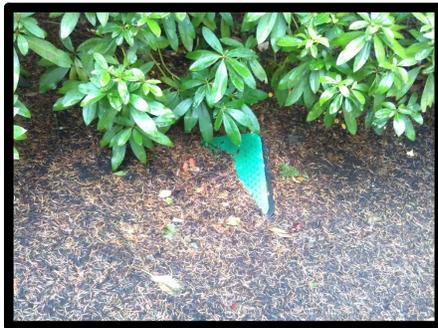
This line item is an allowance to replace the irrigation controllers and associated water valves in the front yards on a 10 year cycle. Date in service is an approximation.

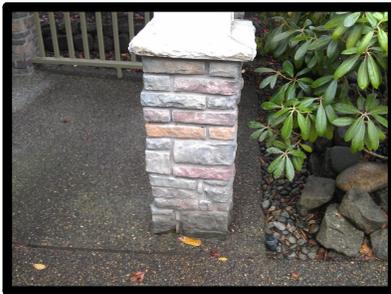
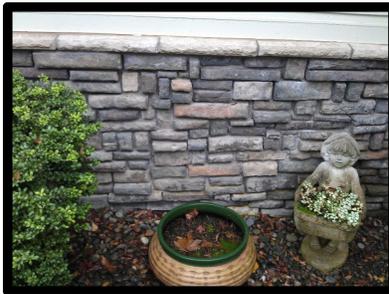
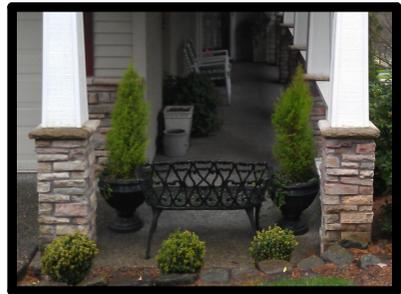
This line item is for the future possible replacement of the stone and mortar located at various locations in the community. Stone has a life expectancy exceeding thirty years, however may require re-sealing and tuck-pointing from time-to-time. This line item currently exceeds the 30-year scope of the reserve study report. A line item has been included in the report for various maintenance events anticipated during the product life cycle.

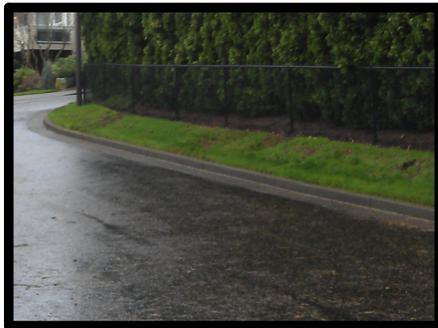
This line item is for the phased replacement or maintenance of concrete along the roadway in the community. Analyst submits that concrete typically has a life expectancy exceeding thirty years and a phased approach addresses the 'here and there' repairs that are likely to be required to prevent possible slip-and-fall hazards.

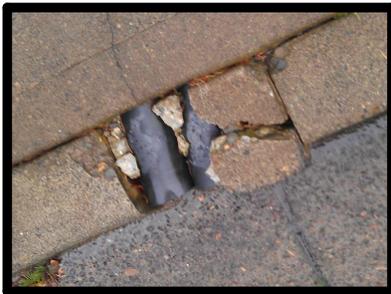
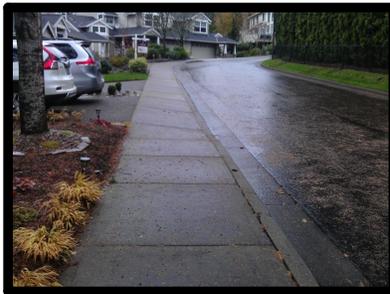
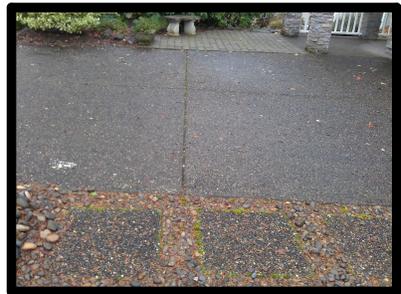
This line item is for the phased replacement or maintenance of concrete along the roadway, sidewalks, patios and other walking surfaces in the community. Analyst submits that concrete typically has a life expectancy exceeding thirty years and a phased approach addresses the 'here and there' repairs that are likely to be required to prevent possible slip-and-fall hazards.

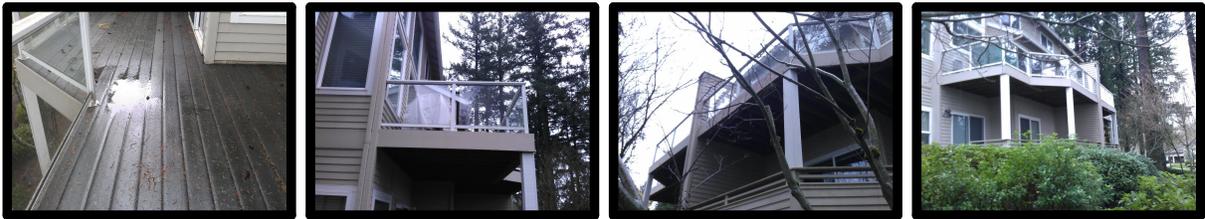
According to the Board of Directors, one deck will be addressed in 2017, while the other 3 elevated decks are scheduled for 2022. This will be reevaluated each year and the future reserve studies will be adjusted in order to compensate. The reserve study report is a constantly moving target and the report will be updated as the facts about the condition are better known. Photos presented above represents photographs from all units, not profiling one specific unit or design.

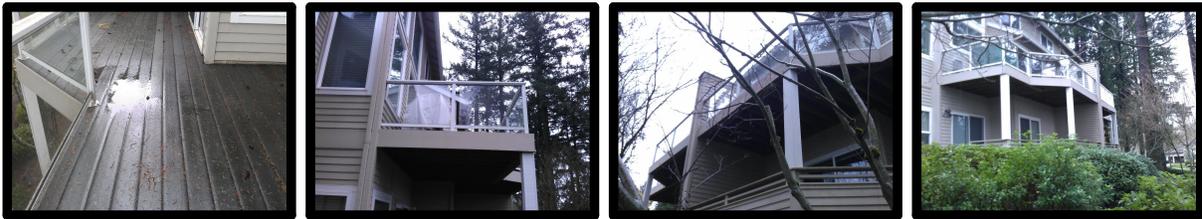
According to the Board of Directors, one deck will be addressed in 2017, while the other 3 elevated decks are scheduled for 2022. This will be reevaluated each year and the future reserve studies will be adjusted in order to compensate. The reserve study report is a constantly moving target and the report will be updated as the facts about the condition are better known. Photos presented above represents photographs from all units, not profiling one specific unit or design.

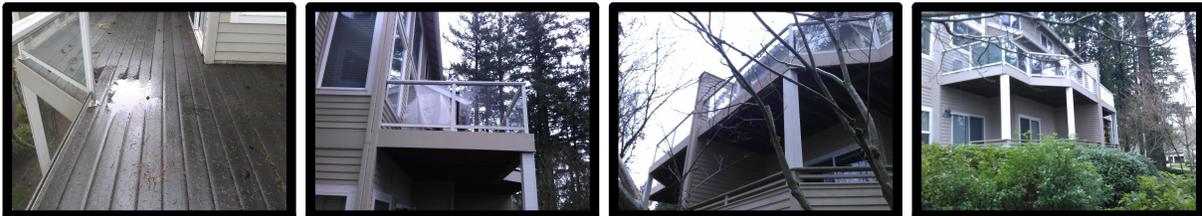
According to the Board of Directors, one deck will be addressed in 2017, while the other 3 elevated decks are scheduled for 2022. This will be reevaluated each year and the future reserve studies will be adjusted in order to compensate. The reserve study report is a constantly moving target and the report will be updated as the facts about the condition are better known. Photos presented above represents photographs from all units, not profiling one specific unit or design.
