# 2017 Reserve Study & Maintenance Plan

## San Francisco Square Condominium Portland, Oregon

April 18, 2017

February 21, 2017

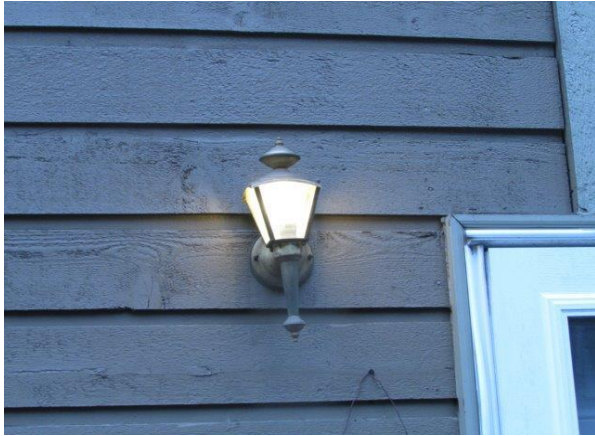
Item Description	# of Items	Unit	Current Item Cost	Future Replacement Cost	Year Built	Useful Life	Year Replace	Life Left	One Time?
Lights-Exterior-Building	17	Fixtures	\$ 75.00	\$ 1,355	1994	25	2019	3	No
<p><b>Comments:</b> This component will serve as a budget fund for replacement as needed. Recommend that the board make efforts to perform work in lump sums in order to reduce varying useful life and contractor mobilization costs. Also, recommend at the time of replacement board consult vendors to perform a fixture replacement energy audit.</p>									
Lights-Exterior-Pole-Florescent-Head Only	2	Fixtures	\$ 175.00	\$ 380	2010	10	2020	4	No
Lights-Exterior-Pole-Halogen-Head Only	2	Fixtures	\$ 475.00	\$ 1,118	2004	20	2024	8	No
<p><b>Comments:</b> 2015: Repair work completed by Westside Electric \$400</p>									
Mailboxes	17	Units	\$ 115.00	\$ 3,000	2007	30	2037	21	No
Paint Exterior-Post Residing	17	Units	\$ 1,700.00	\$ 54,378	2039	8	2047	31	No

For appearance and security, all exterior light fixtures should be in good working order. Inspect and repair fixtures or replace bulbs as needed.

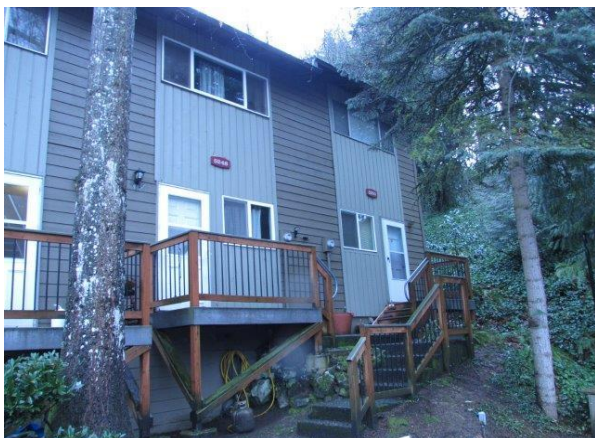
Paint-Exterior-2020	17	Units	\$ 2,000.00	\$ 36,889	2013	7	2020	4	No
<p><b>Comments:</b> 2013: Manager advised the estimated cost of work completed in 2010 was \$11,000.</p>									
Parking-Bumpers-Recycled	34	Each	\$ 100.00	\$ 3,842	2007	15	2022	6	No
<p><b>Comments:</b> 2013: Observed center anchors missing at each location. Recommend adding additional anchors.</p>									
Paving-Overlay	9,500	Sq.Ft.	\$ 1.75	\$ 25,511	1997	40	2037	21	No
<p><b>Comments:</b> Under average traffic conditions, and regular and adequate cycles of repair, crack seal and sealcoating, a properly installed asphalt pavement should last 30–40 years. Heavy truck traffic like garbage trucks can accelerated damage to the traffic lane. Sealcoating should be applied within 2 years of installation date</p>									
Paving-Repair, Crackseal & Sealcoat	9,500	Sq.Ft.	\$ 0.40	\$ 3,958	2013	5	2018	2	No
<p><b>Comments:</b> Asphalt is a porous material that is deteriorated by water, dirt, oil and sunlight. To protect it from the elements, a sealcoating should be applied as paint is applied to siding. Sealcoating will seal against water, protect against UV rays which break it down, keep the asphalt from drying out and extend its useful life. It is highly recommended that two coats be applied to achieve the estimated useful life. Restriping (if applicable) included in the cost. 2015: Striping of parking lot completed \$350 2013: Budget cost \$3,698 (\$0.39/sf) provided by Coast Paving</p>

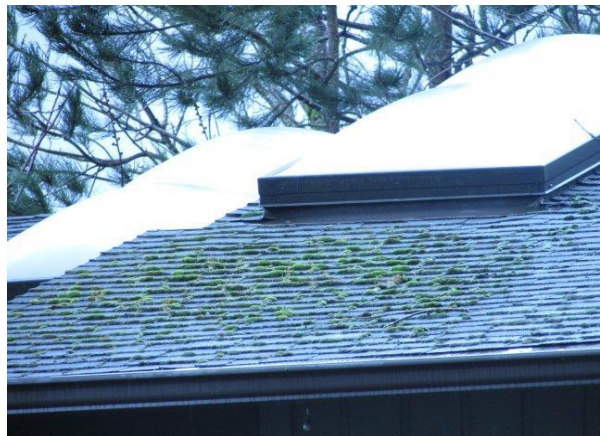
Item Description	# of Items	Unit	Current Item Cost	Future Replacement Cost	Year Built	Useful Life	Year Replace	Life Left	One Time?
Rec Room-Hot Water Heater	1	Total	\$ -	\$ -	2017	50	2067	51	No
<b>Comments:</b> 2017: Board reported out of commission, no future plans to replace/put into service.									
Rec Room-Lights-Interior	5	Fixtures	\$ 50.00	\$ 307	2001	25	2026	10	No
Rec Room-Paint-Interior	1	Total	\$ -	\$ -	2017	50	2067	51	No
<b>Comments:</b> 2017: Board reported no future plans to paint.									
Rec Room-Ping Pong Table	1	Total	\$ 300.00	\$ 375	2012	15	2027	11	No
Rec Room-Windows	5	Each	\$ 450.00	\$ 3,055	1971	60	2031	15	No
Roof-Composition	130	Squares	\$ 350.00	\$ 50,384	1996	25	2021	5	No
<b>Comments:</b> Base year "Year Built" reflected is start of repair budget cycle. 2017: Observed moss on section of roof. Per conversation with Leo Construction, roofs are 13 year old and in "bad shape". Sample shingles are being submitted to manufacturer for testing to determine if warranty applies. Advised roof needs replacement within 5 years and a budget replacement cost of \$350/square is appropriate. Repair work completed by Leo Construction \$1,700 2002-2004: Roof installed.

To ensure the roof lasts its normal useful life, the roof must be kept clean of debris, moss and algae. Each year, a qualified roof maintenance contractor should inspect, clean and repair the roof as needed.

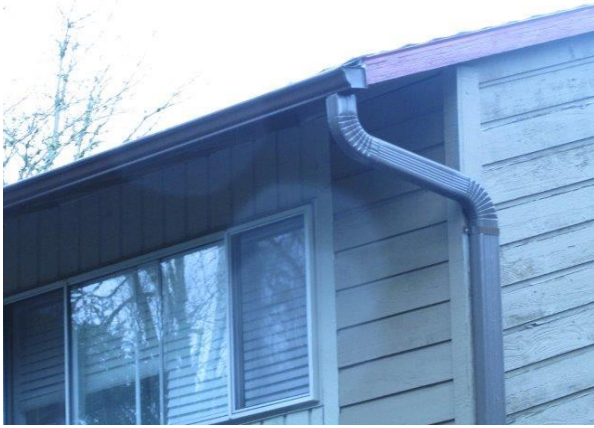
Roof-Gutters & Downspouts	800	Ln.Ft.	\$ 6.00	\$ 5,315	1996	25	2021	5	No
<b>Comments:</b> 2017: Observed disconnected downspout at unit #5218. 2013: Observed sagging gutter above unit #5234.									
Roof-Skylight	1	Total	\$ -	\$ -	2016	50	2066	50	No
<b>Comments:</b> Skylights are owner responsibility.									
Siding & Trim Repair	17	Units	\$ 150.00	\$ 2,767	2013	7	2020	4	No
<b>Comments:</b> Prior to performing Paint-Exterior, all siding and trim should be carefully inspected, repaired or replaced as needed. Caulking around all doors, windows and trim should be performed.									
Siding-Inspection	1	Total	\$ 3,500.00	\$ 3,572	2015	2	2017	1	Yes
<b>Comments:</b> A siding assessment provides information regarding the performance of the building enclosure components, identifies areas of concern and provides the information needed to create appropriate planning for the building's maintenance and repair. If it is deemed that a replacement of the siding (or portions of it) will be necessary within the next 30 years, a replacement line item should be added to the reserve budget.

Gutters and downspouts should be inspected regularly, kept clear of debris, and repaired as needed.

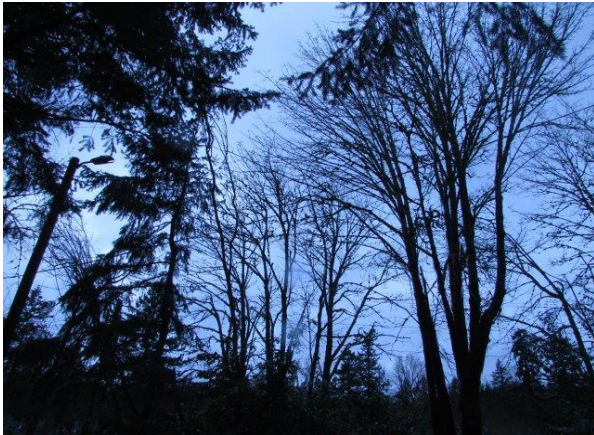
Sign-Unit #'s-Wood	17	Units	\$ 75.00	\$ 1,662	2013	16	2029	13	No
<p><b>Comments:</b> Coordinate with every other paint cycle and/or siding replacement.</p>									
Treework	1	Total	\$ 3,000.00	\$ 3,125	2015	3	2018	2	No
<p><b>Comments:</b> Have trees inspected by arborist and perform corrective pruning as needed to keep tree limbs at least 6' away from buildings. Tree limbs overhanging roofs and decks will damage and shorten the useful life of that component. Use this fund as needed over a 3 year period; list year, work done and cost here. Revise next cycle's budget according to arborist's recommendations.</p>									
Wall-Retaining-Railroad Ties-Rock	1	Total	\$ 6,500.00	\$ 6,771	2013	5	2018	2	No
<p><b>Comments:</b> Highly recommend that the board have the retaining wall inspected by a licensed professional. If it is determined at that time that additional supports, or replacement are warranted add the associated cost and recommended replacement year to the reserve budget.</p> <p>2013: Estimated replacement cost (\$5,300) and useful life (2-5 years) provided by Tryon Creek Landscape; Observed (3) large trees damaging wall.</p>

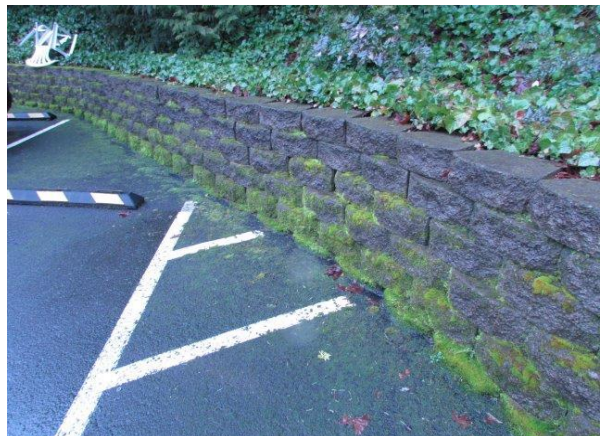
Wall-Retaining-Stacked CMU	1	Total	\$ 1,000.00	\$ 1,201	2015	10	2025	9	No
<p><b>Comments:</b> 3ft X 150ft</p> <p>Use this budget as needed over 10 year period for minor repairs.</p>
