# 2017 Reserve Study & Maintenance Plan

## San Francisco Square Condominium Portland, Oregon

April 18, 2017

February 21, 2017

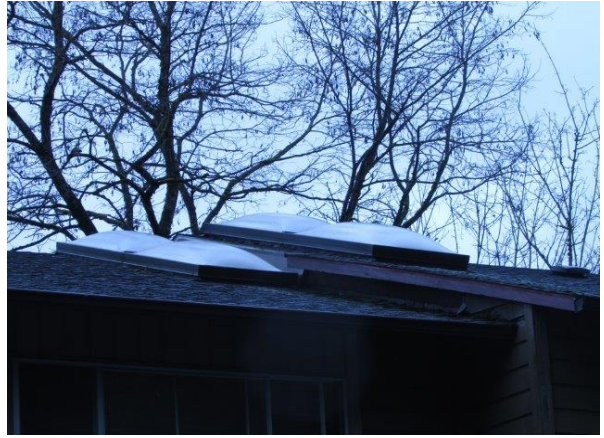
Roof-Gutters & Downspouts	800	Ln.Ft.	\$ 6.00	\$ 5,315	1996	25	2021	5	No
<b>Comments:</b> 2017: Observed disconnected downspout at unit #5218. 2013: Observed sagging gutter above unit #5234.									
Roof-Skylight	1	Total	\$ -	\$ -	2016	50	2066	50	No
<b>Comments:</b> Skylights are owner responsibility.									
Siding & Trim Repair	17	Units	\$ 150.00	\$ 2,767	2013	7	2020	4	No
<b>Comments:</b> Prior to performing Paint-Exterior, all siding and trim should be carefully inspected, repaired or replaced as needed. Caulking around all doors, windows and trim should be performed.									
Siding-Inspection	1	Total	\$ 3,500.00	\$ 3,572	2015	2	2017	1	Yes
<b>Comments:</b> A siding assessment provides information regarding the performance of the building enclosure components, identifies areas of concern and provides the information needed to create appropriate planning for the building's maintenance and repair. If it is deemed that a replacement of the siding (or portions of it) will be necessary within the next 30 years, a replacement line item should be added to the reserve budget.

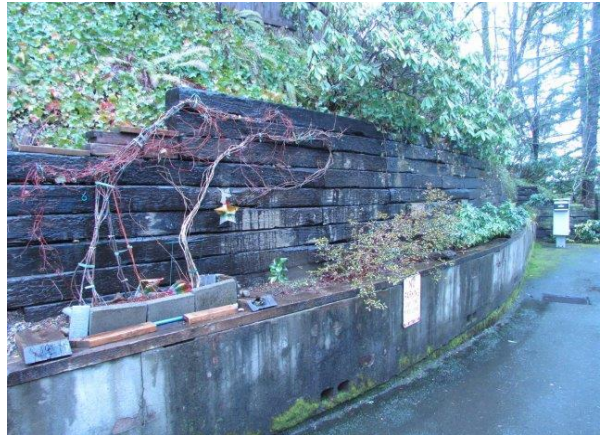
Sign-Unit #'s-Wood	17	Units	\$ 75.00	\$ 1,662	2013	16	2029	13	No
<p><b>Comments:</b> Coordinate with every other paint cycle and/or siding replacement.</p>									
Treework	1	Total	\$ 3,000.00	\$ 3,125	2015	3	2018	2	No
<p><b>Comments:</b> Have trees inspected by arborist and perform corrective pruning as needed to keep tree limbs at least 6' away from buildings. Tree limbs overhanging roofs and decks will damage and shorten the useful life of that component. Use this fund as needed over a 3 year period; list year, work done and cost here. Revise next cycle's budget according to arborist's recommendations.</p>									
Wall-Retaining-Railroad Ties-Rock	1	Total	\$ 6,500.00	\$ 6,771	2013	5	2018	2	No
<p><b>Comments:</b> Highly recommend that the board have the retaining wall inspected by a licensed professional. If it is determined at that time that additional supports, or replacement are warranted add the associated cost and recommended replacement year to the reserve budget.</p> <p>2013: Estimated replacement cost (\$5,300) and useful life (2-5 years) provided by Tryon Creek Landscape; Observed (3) large trees damaging wall.</p>
